# Manhole Inspection Summary

Manhole # S39E\_\_002MH

Insp Date: **7/20/09 1:34 PM**

**Location** Address: **1101 Comet St.**

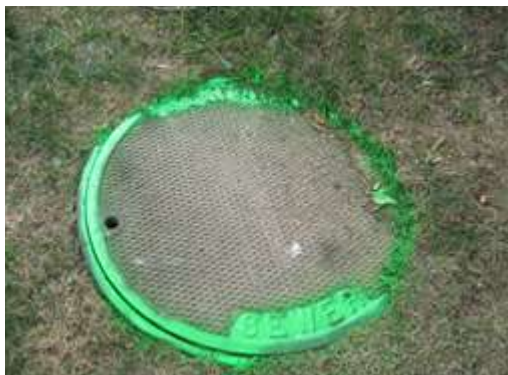
MH Cover

Condition: **Sound**

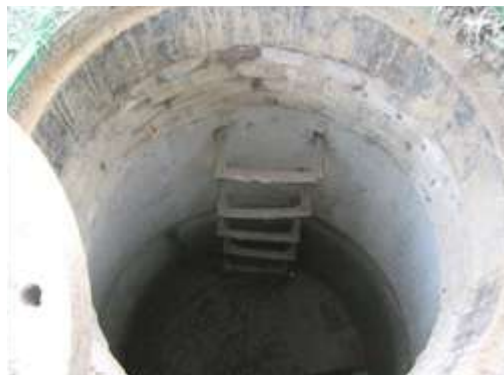
MH Steps

**Steps** Count: **5** Missing: **0** ☐ Corroded

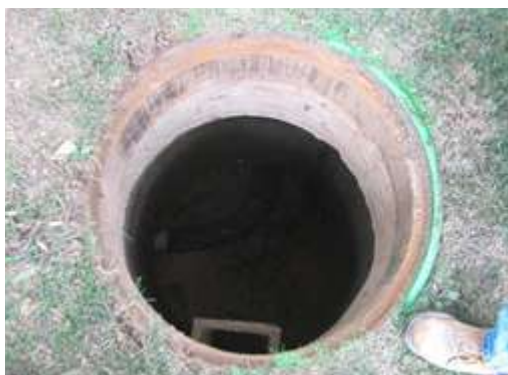
Frame View

**Frame** Offset: **0** (in.) Condition: ☒ Sound ☐ Cracked ☐ Leaks

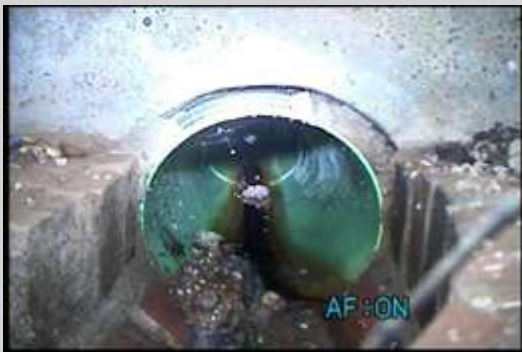
12 O'Clock Outflow

8 in. Circular Gravity Sewer  
Pipe Out @ 12 O'Clock

Pipe Height: **7.2** (in.) Rod and Bar (Angled)  
Pipe Material: **PVC** ☐ Pipe Lined  
Invert Depth: **8.22** (ft.) Flow Characteristics: **None**  
Deposits: ☒ None ☐ Mud ☐ Sludge ☐ Debris ☐ Grease  
Silt Depth: **0** (in.) Deposits Extent:  
Infiltration: **None** Pipe Seal Cond: **Sound**

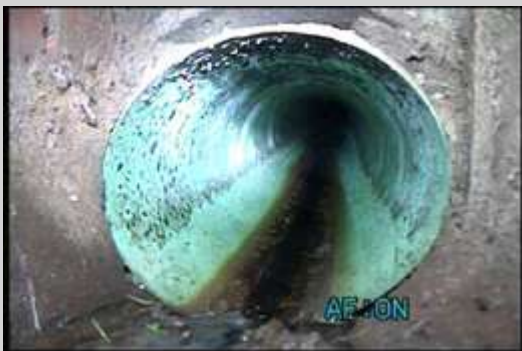
9 O'Clock Inflow

6 in. Circular Gravity Sewer  
Pipe In @ 9 O'Clock

Pipe Height: **6** (in.) Rod and Bar (Angled)  
Pipe Material: **PVC** ☐ Pipe Lined  
Invert Depth: **8.06** (ft.) Flow Characteristics: **None**  
Deposits: ☒ None ☐ Mud ☐ Sludge ☐ Debris ☐ Grease  
Silt Depth: **0** (in.) Deposits Extent:  
Infiltration: **None** Pipe Seal Cond: **Sound**
